REPORT NUMBER: 201U-VER-04-05

**SAFETY COMPLIANCE TESTING FOR FMVSS 201  
OCCUPANT PROTECTION IN INTERIOR IMPACT  
UPPER INTERIOR HEAD IMPACT PROTECTION**

**AUTO ALLIANCE INTERNATIONAL INC. FOR MAZDA MOTOR CORPORATION  
2004 MAZDA 6 4-DOOR SEDAN**

**FINAL REPORT**

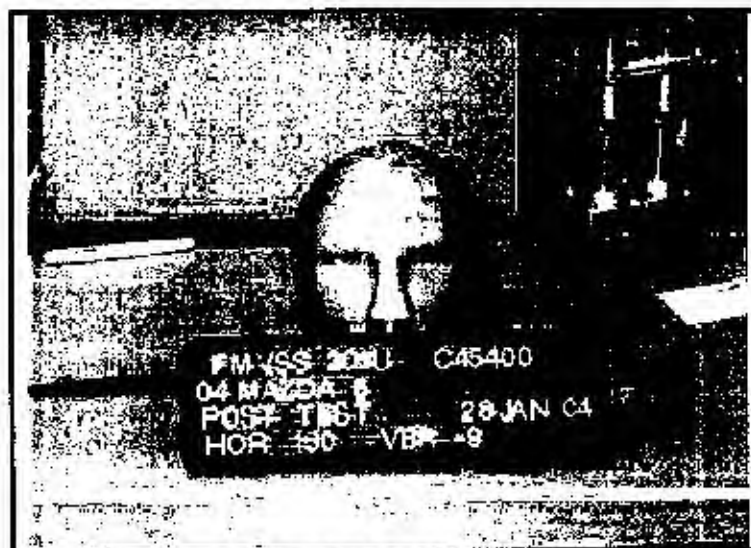
POST-IMPACT BP4 HEADFORM

Free Motion HIC	678.2
HIC(d)	678.1
Impact Velocity (kph)	23.73
HIC T1 (msec)	1.4
HIC T2 (msec)	8.9

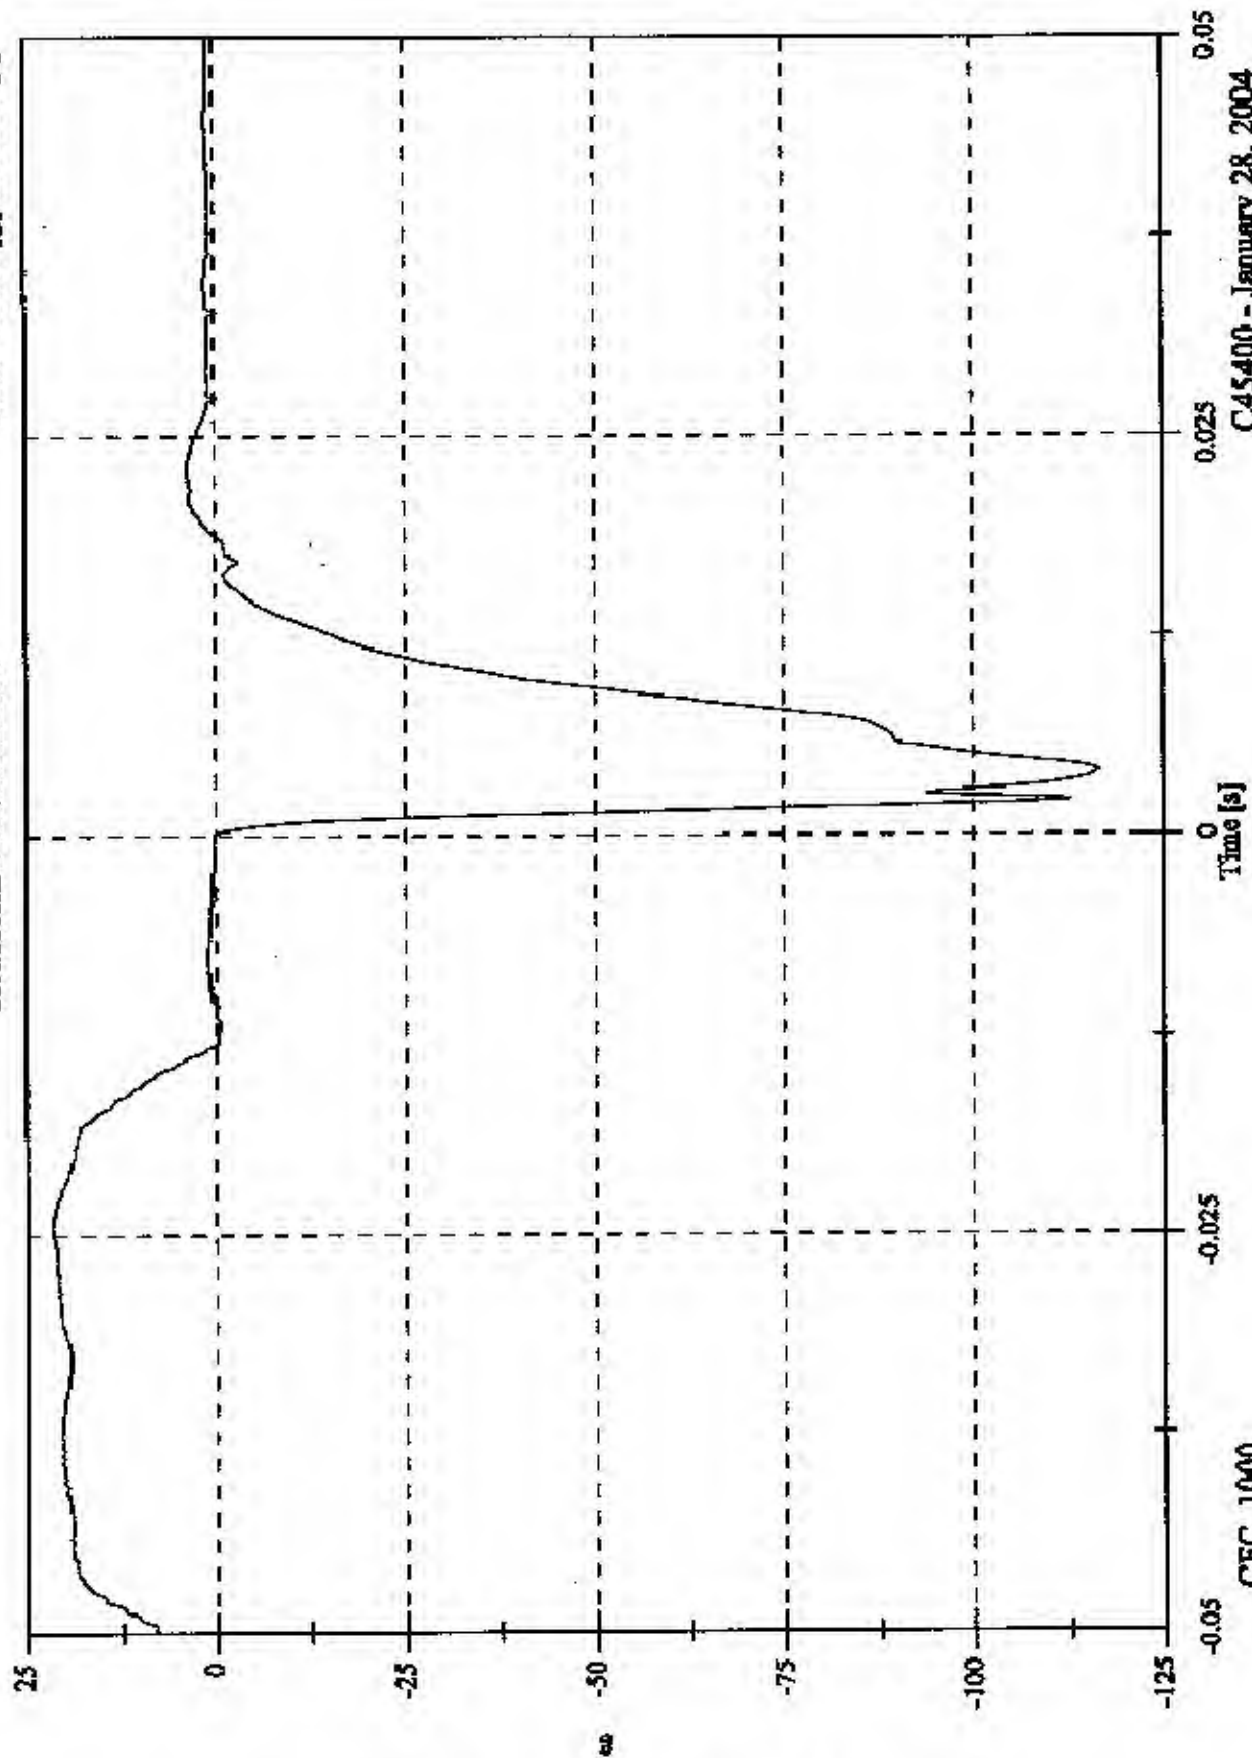
Max: 21.5 [g] at -0.024 [s]  
Min: -116.4 [g] at 0.004 [s]

Headform X Acceleration

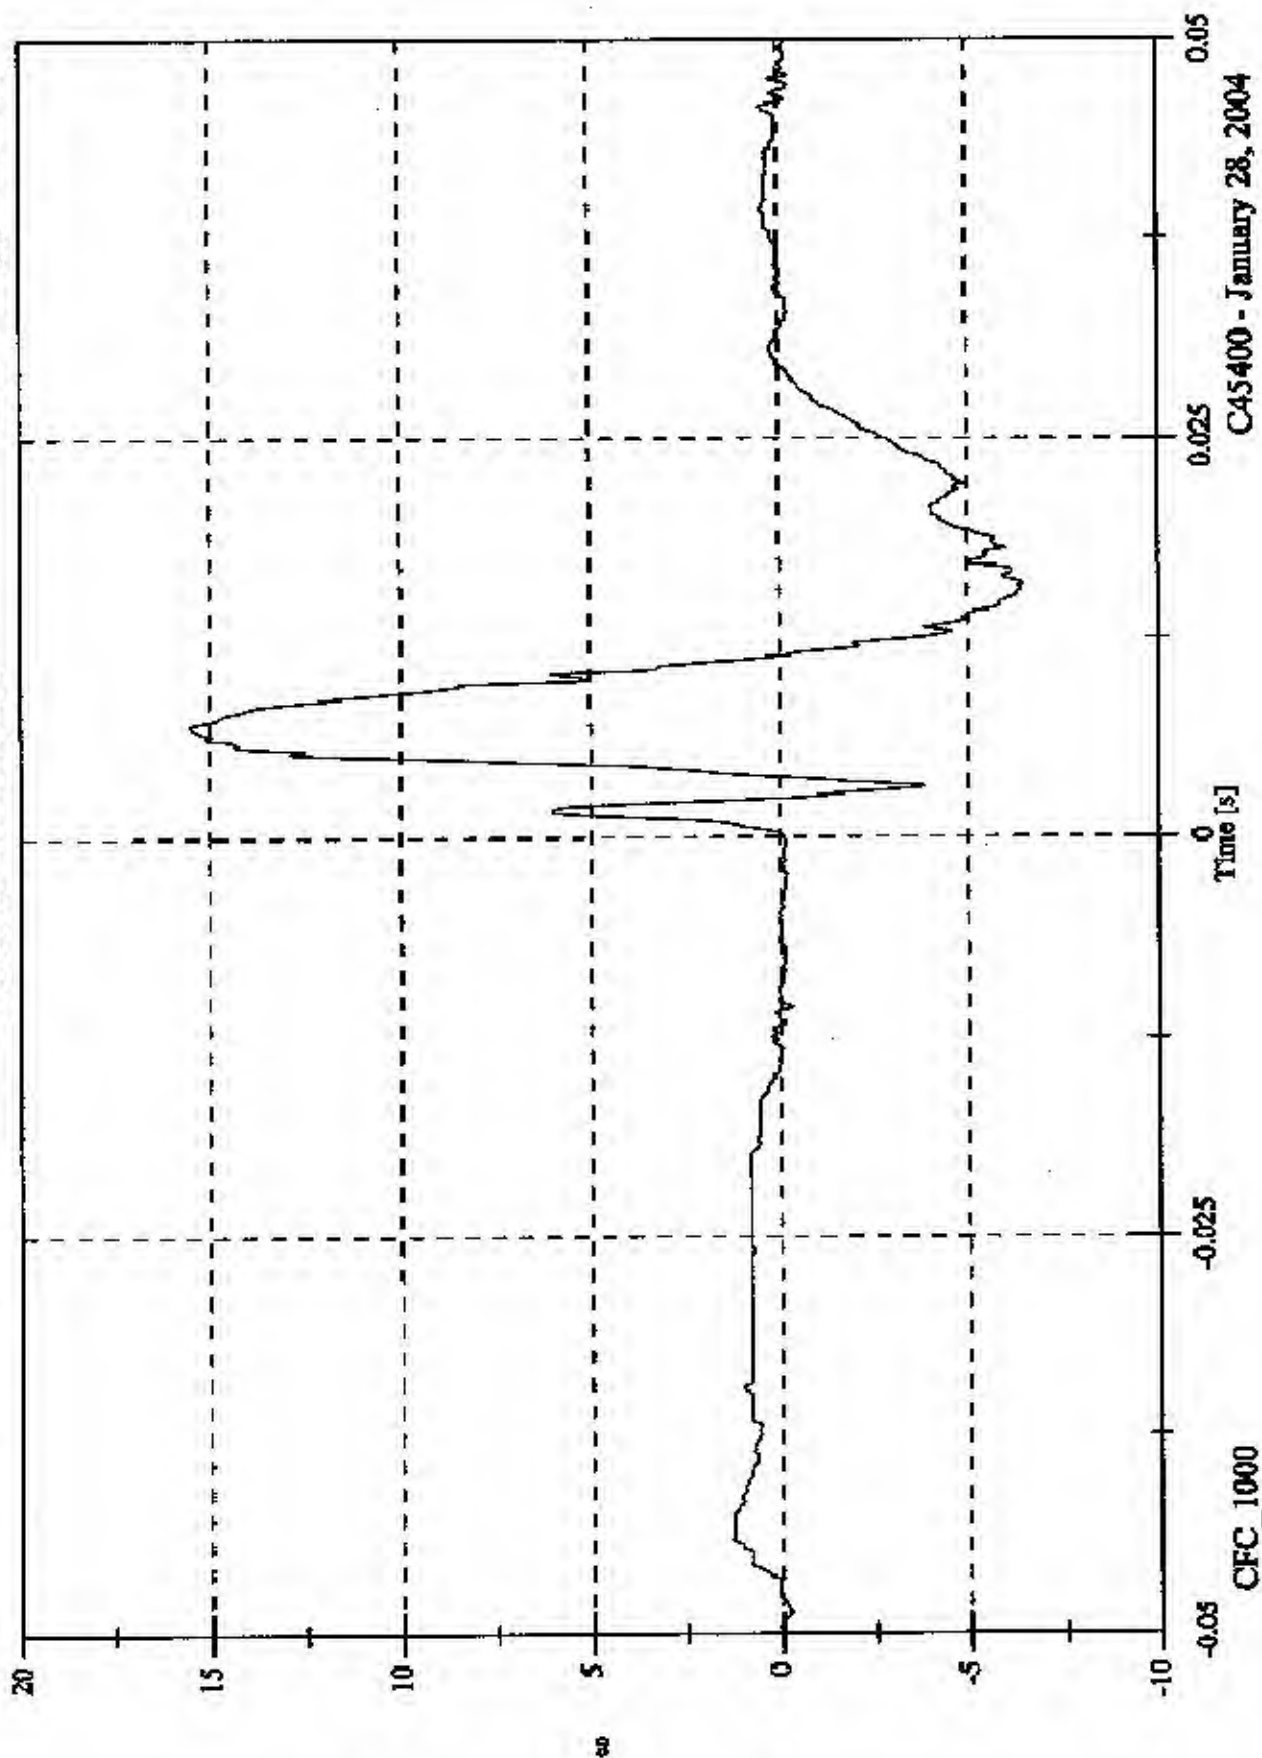
Headform Y Acceleration

Max: 15.6 [g] at 0.007 [s]  
Min: -6.5 [g] at 0.016 [s]

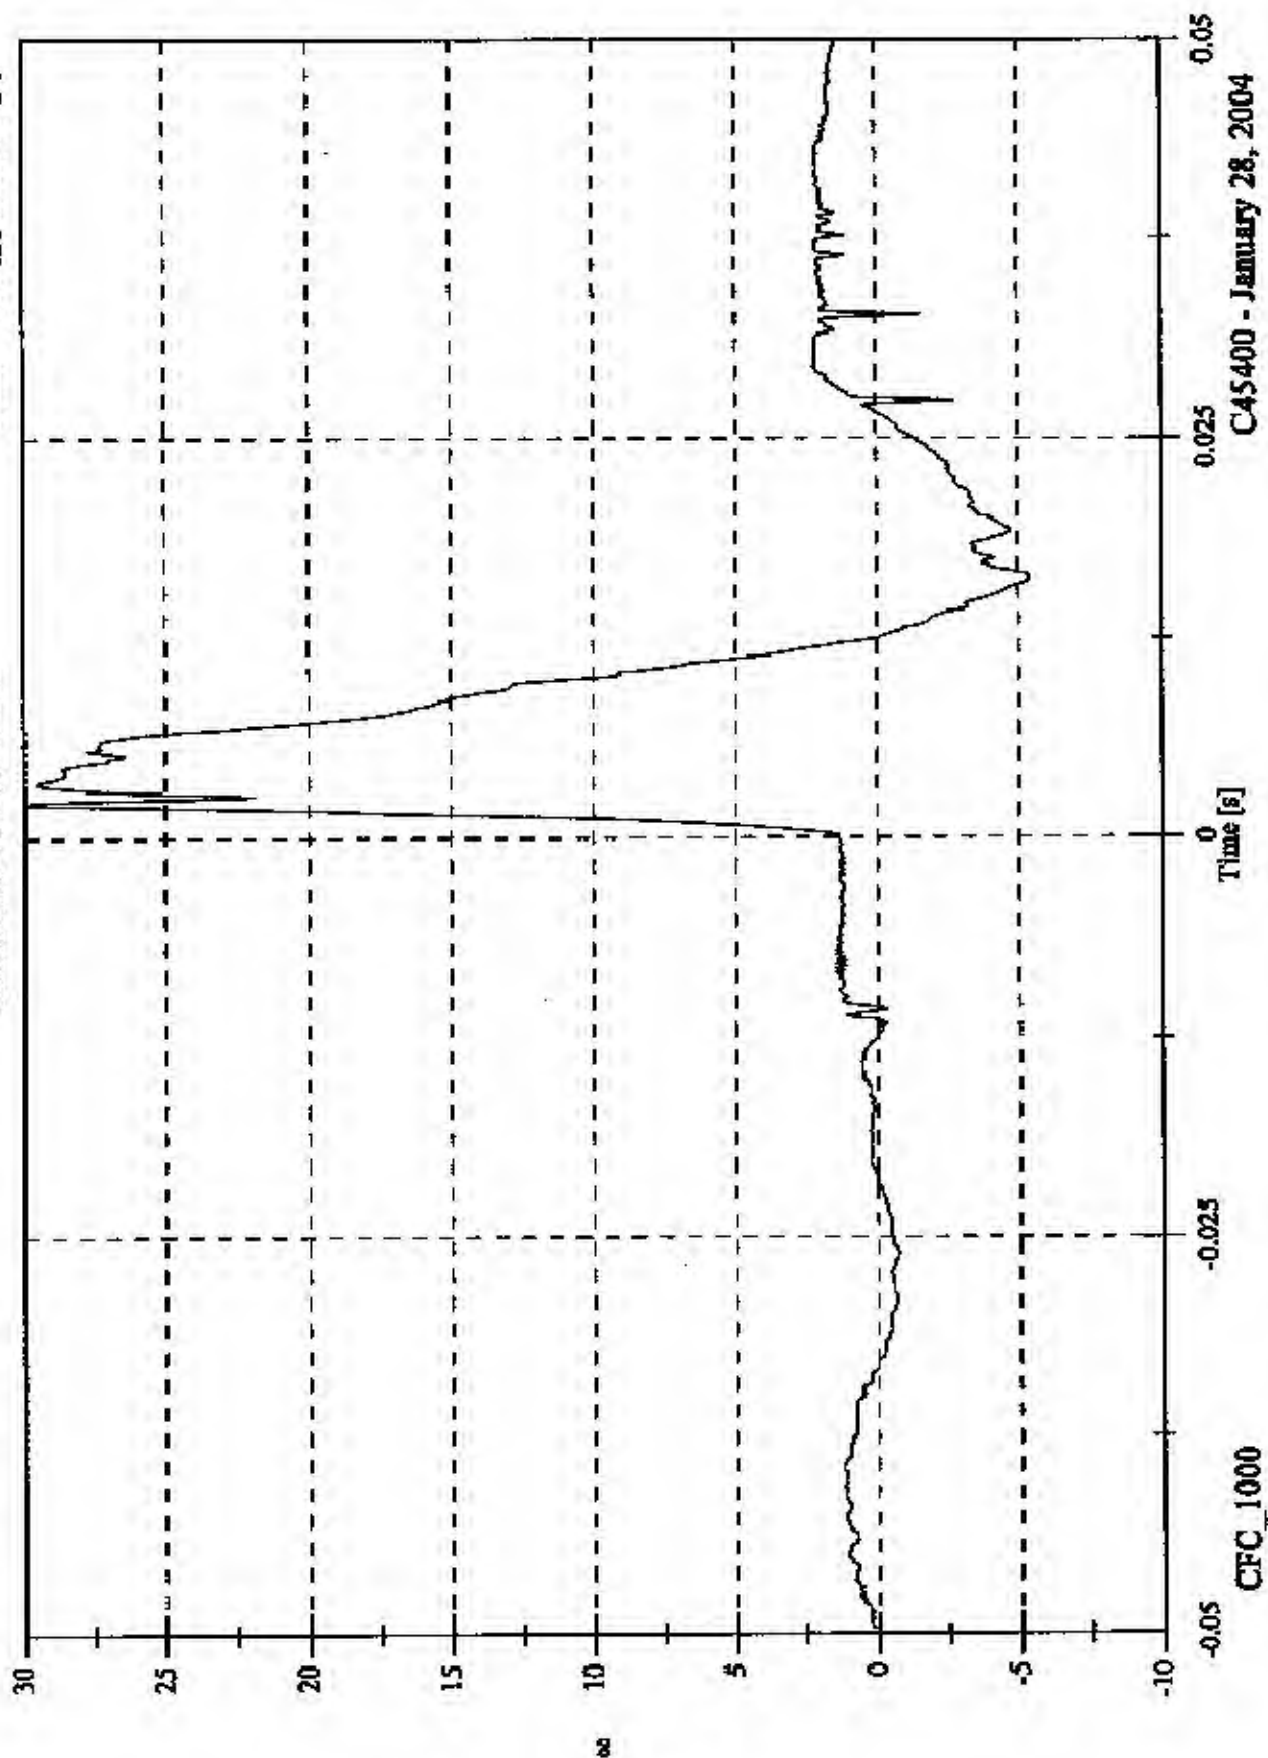
C45400 Passenger Side BP4 Impact Plot #3

Max: 30.0 [g] at 0.002 [s]  
Min: -5.4 [g] at 0.016 [s]

Headform Z Acceleration

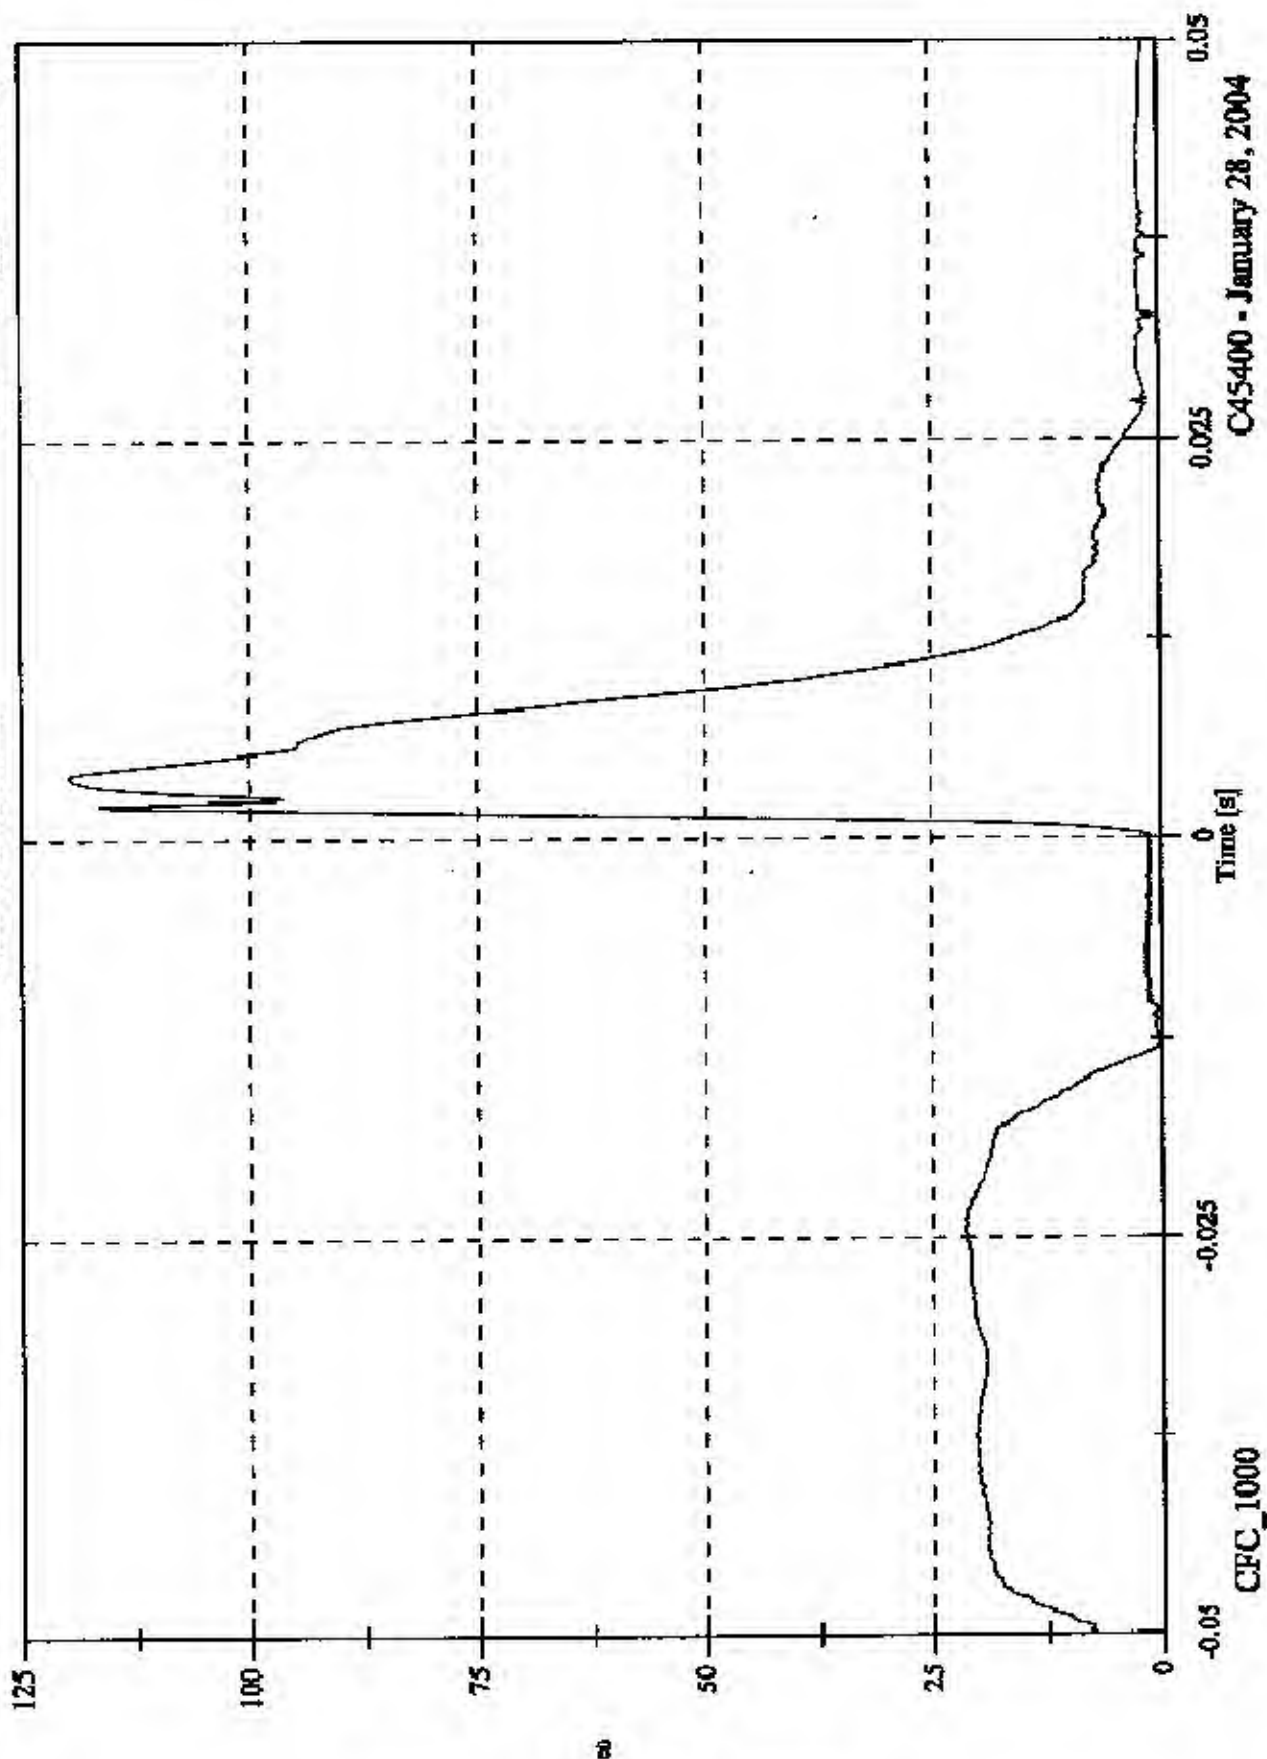
C45400 Passenger Side BP4 Impact Plot #4

Max: 119.9 [g] at 0.004 [s]  
Min: 0.2 [g] at -0.011 [s]

Headform Resultant

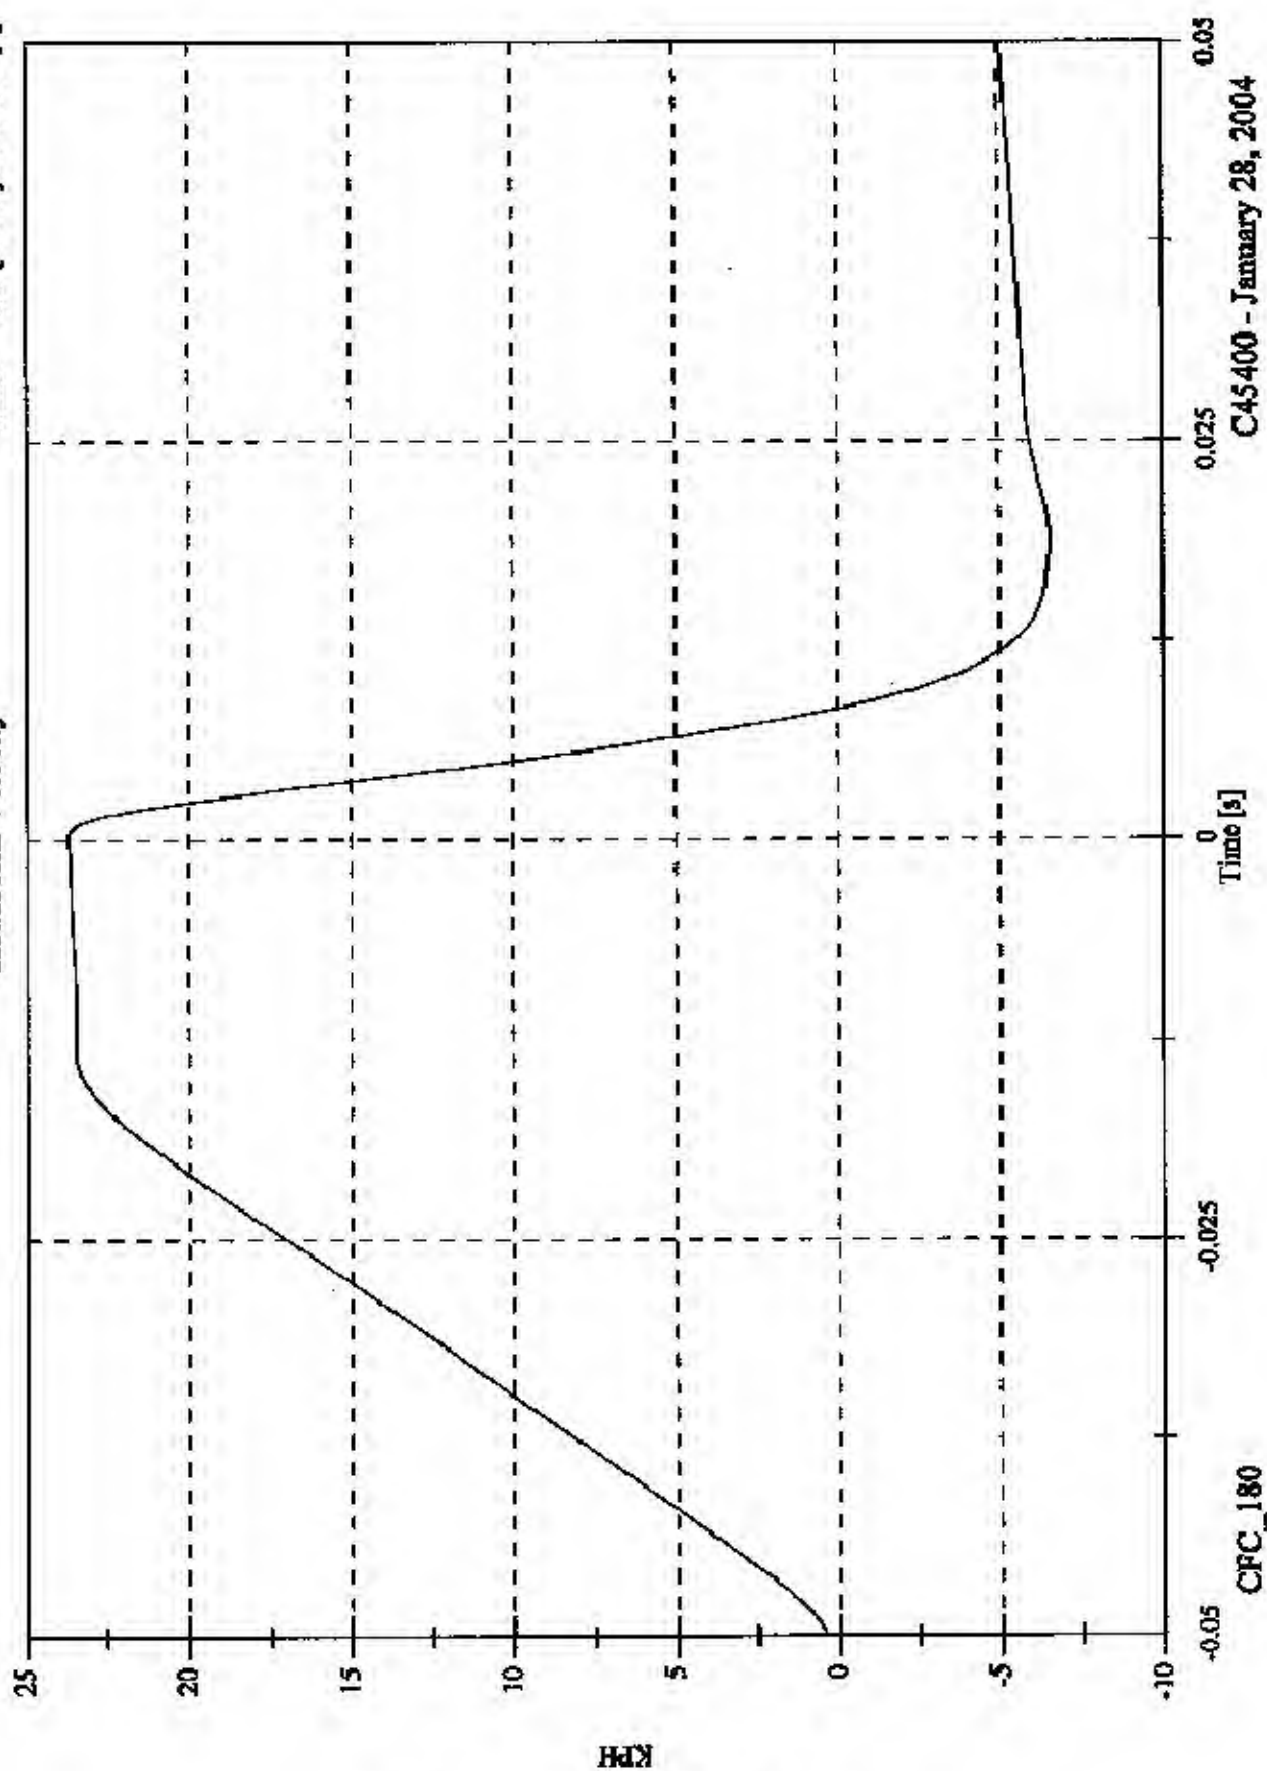
C45400 Passenger Side BP4 Impact Plot #5

Max: 23.7 [KPH] at 0.000 [s]  
Min: -6.5 [KPH] at 0.019 [s]

Headform Velocity

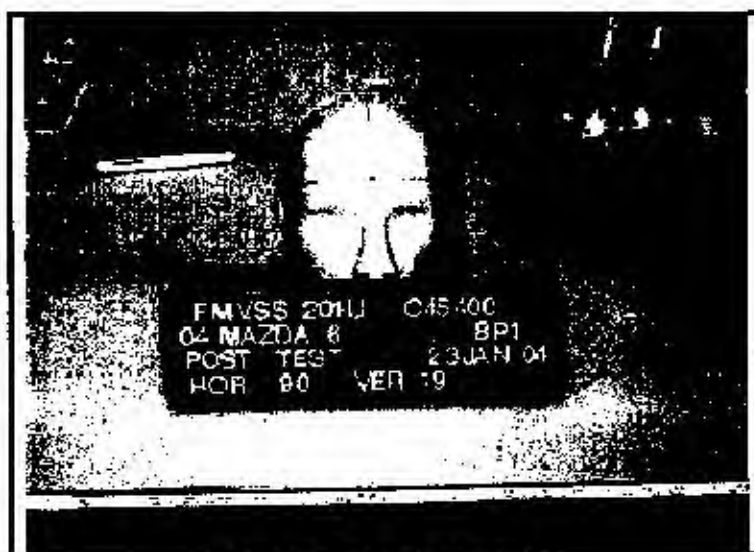
POST-IMPACT BP1 HEADFORM

Free Motion HIC	537.4
HIC(d)	571.8
Impact Velocity (kph)	23.54
HIC T1 (msec)	21
HIC T2 (msec)	12.6

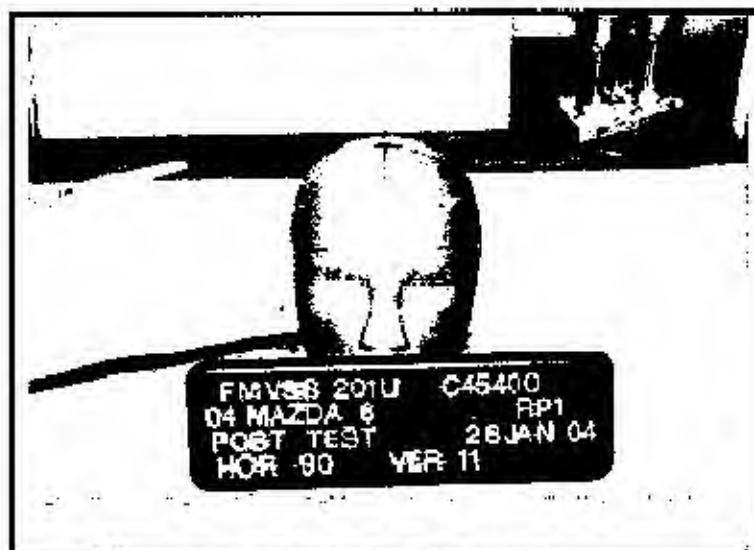
POST-IMPACT RP1 HEADFORM

Free Motion HIC	521.3
HIC(d)	559.7
Impact Velocity (kph)	23.73
HIC T1 (msec)	2.9
HIC T2 (msec)	13.0

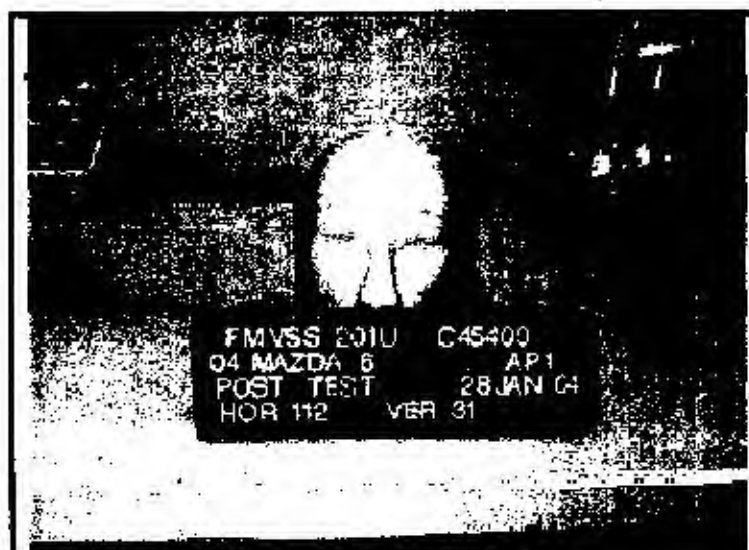
POST-IMPACT AP1 HEADFORM

Free Motion HIC	857.1
HIC(d)	813.0
Impact Velocity (kph)	23.58
HIC T1 (msec)	2.3
HIC T2 (msec)	8.3

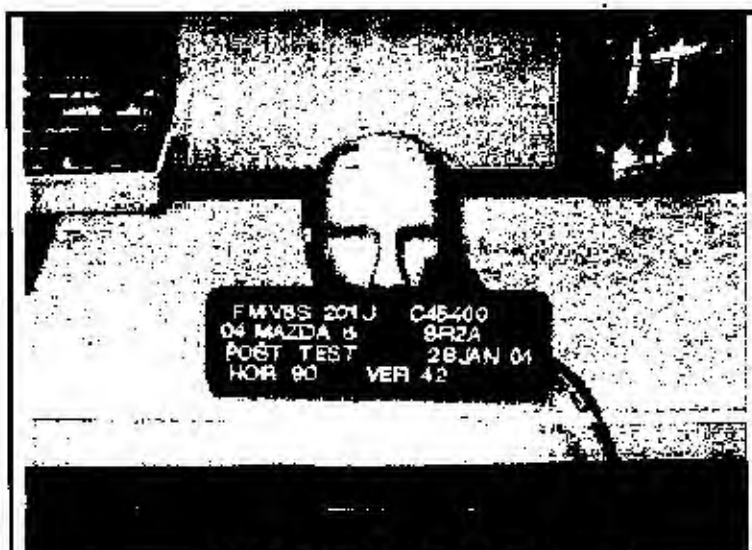
POST-IMPACT SR2A HEADFORM

Free Motion HIC	622.2
HIC(d)	635.8
Impact Velocity (kph)	23.62
HIC T1 (msec)	1.1
HIC T2 (msec)	7.9

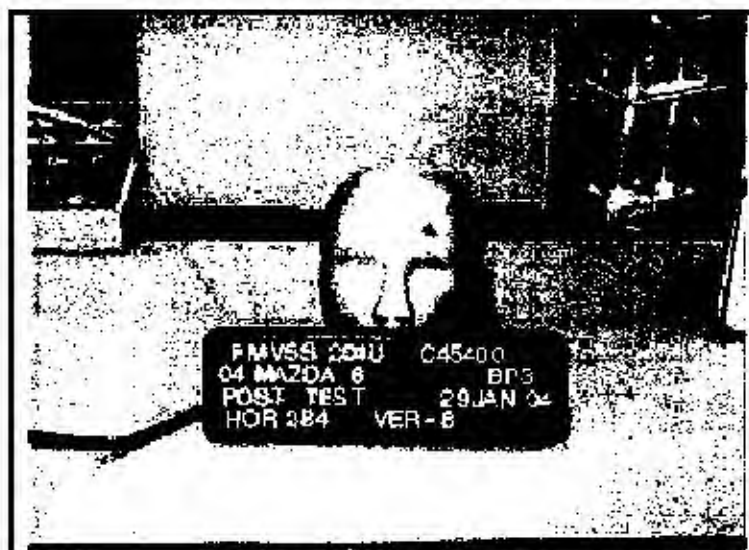
POST-IMPACT BP3 HEADFORM

Free Motion HIC	839.4
HIC(d)	799.7
Impact Velocity (kph)	23.50
HIC T1 (msec)	4.4
HIC T2 (msec)	7.3

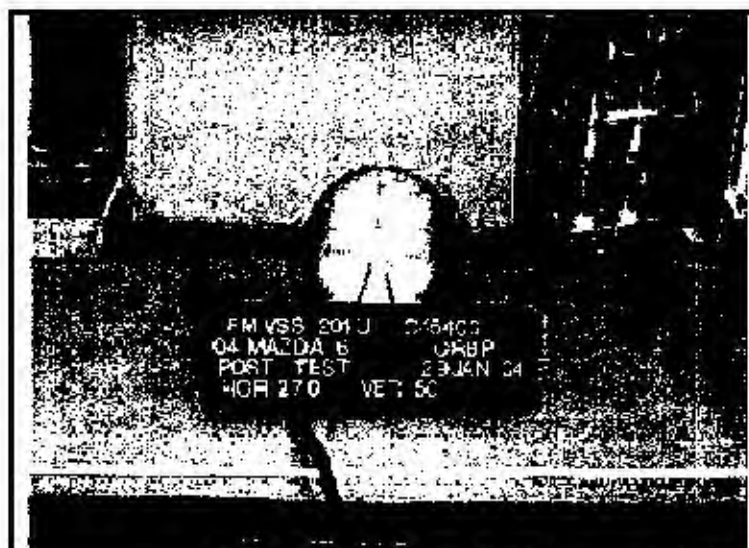
POST-IMPACT UREP HEADFORM

Free Motion HIC	669.9
HIC(d)	671.6
Impact Velocity (kph)	23.50
HIC T1 (msec)	3.9
HIC T2 (msec)	11.1

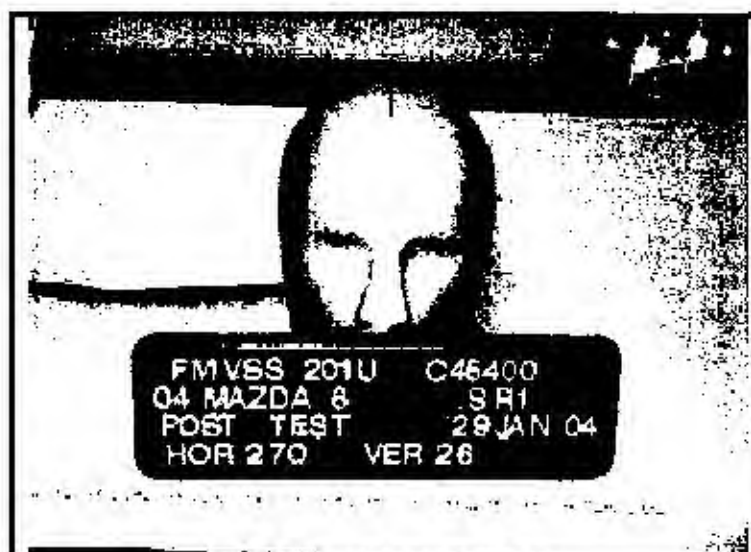
POST-IMPACT SRI HEADFORM

Free Motion HIC	409.8
HIC(d)	475.5
Impact Velocity (kph)	23.56
HIC T1 (msec)	2.3
HIC T2 (msec)	14.1
